Medical Devices: The Therac-25*

Nancy Leveson
University of Washington

1 Introduction

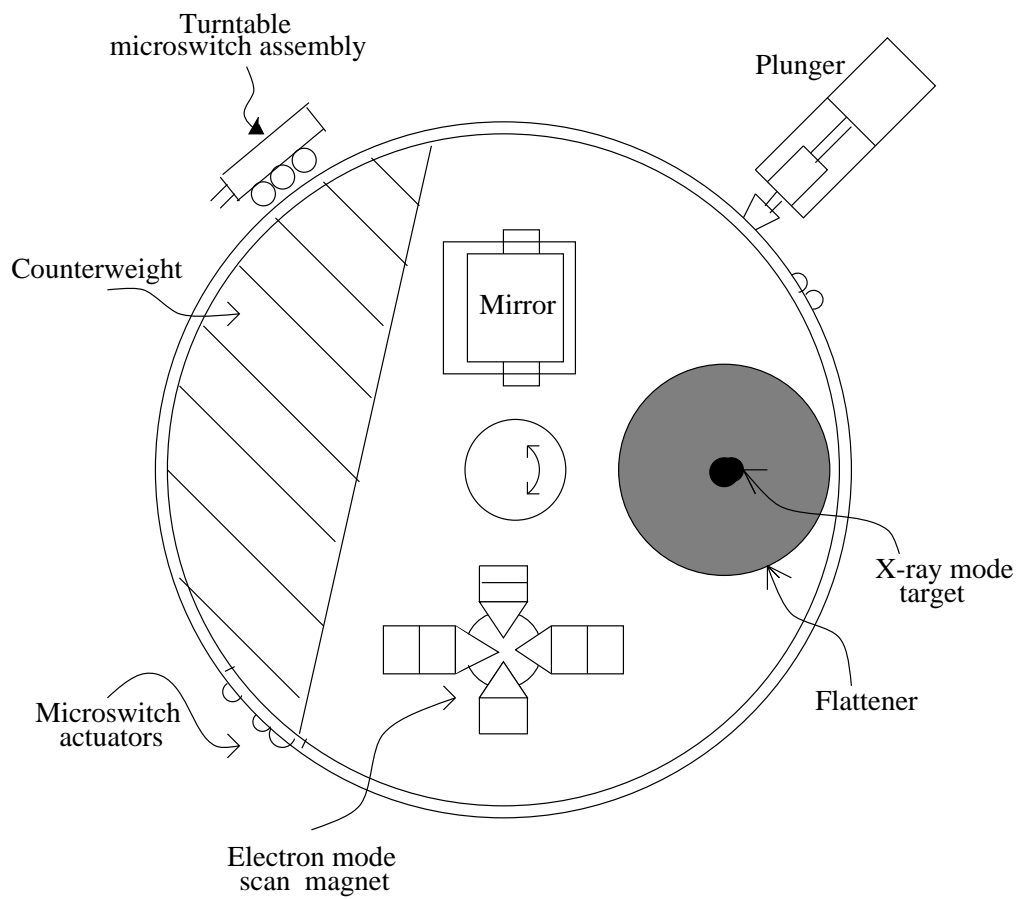
Figure 1: Upper turntable assembly.

Turntable Positioning. The Therac-25 turntable design plays an important role in the accidents. The upper turntable (see Figure 1) rotates accessory equipment into the beam path to produce two therapeutic modes: electron mode and photon mode. A third position (called the field light position) involves no beam at all, but rather is used to facilitate correct positioning of the patient. Because the accessories appropriate to each mode

are physically attached to the turntable, proper operation of the Therac-25 is heavily dependent on the turntable position, which is monitored by three microswitches.

AECL could not reproduce the malfunction that had occurred, but suspected a transient failure in the microswitch used to determine the turntable position. During the investigation of the accident, AECL hardwired the error conditions they assumed were necessary for the malfunction and, as a result, found some turntable positioning design weaknesses and potential mechanical problems.

The computer senses and controls turntable position by reading a 3-bit signal about the status of three microswitches in the turntable switch assembly. Essentially, AECL determined that a 1-bit error in the microswitch codes (which could be caused by a single open-circuit fault on the switch lines) could produce an ambiguous position message to the computer. The problem was exacerbated by the design of the mechanism that extends a plunger to lock the turntable when it is in one of the three cardinal positions: The plunger could be extended when the turntable was way out of position, thus giving a second false position indication. AECL devised a method to indicate turntable position that tolerated a 1-bit error so that the code would still unambiguously reveal correct position with any one microswitch failure.

The modifications specified in the Symonds report included redesigning the microswitch and changing the way the computer handled malfunction conditions. In particular, treatment was to be terminated in the event of a dose-rate malfunction, giving a treatment "suspend." This change would have removed the option to proceed simply by pressing the \textcircled{P} key. The report also made recommendations regarding collimator test procedures and message and command formats. A November 8, 1985 letter, signed by the director of the Canadian RPB, asked that AECL make changes to the Therac-25 based on the Symond's report "to be in compliance with the RED act."

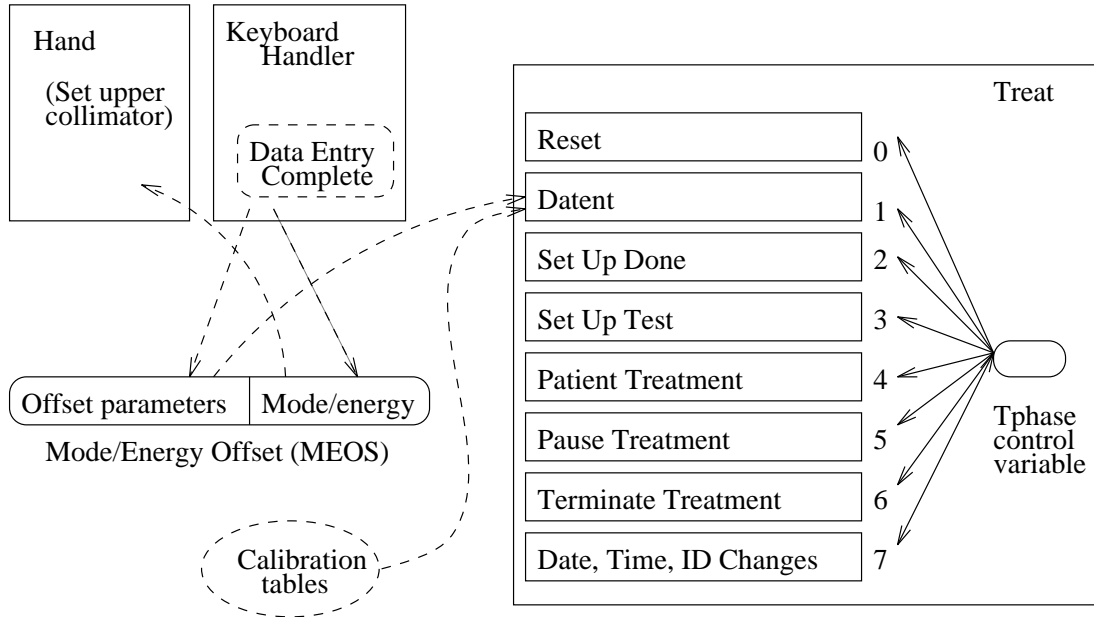
Figure 3: Tasks and subroutines in the code blamed for the Tyler accidents.

The treatment monitor task (Treat) controls the various phases of treatment by executing its eight subroutines. The treatment phase indicator variable (Tphase) is used to determine which subroutine should be executed (Figure 3). Following the execution of a particular subroutine, Treat reschedules itself.

But this is not the only problem. Upon exit from the Magnet subroutine, the data entry subroutine (Datent) checks the Data Entry Complete variable. If it indicates that data entry is complete, Datent sets Tphase to 3 and Datent is not entered again. If it is not set, Datent leaves Tphase unchanged, which means it will eventually be rescheduled. But the Data Entry Complete variable only indicates that the cursor has been down to the command line, not that it is still there. A potential race condition is set up. To fix this, AECL introduced another shared variable controlled by the keyboard handler task that indicates the cursor is not positioned on the command line. If this variable is set, then prescription entry is still in progress and the value of Tphase is left unchanged.

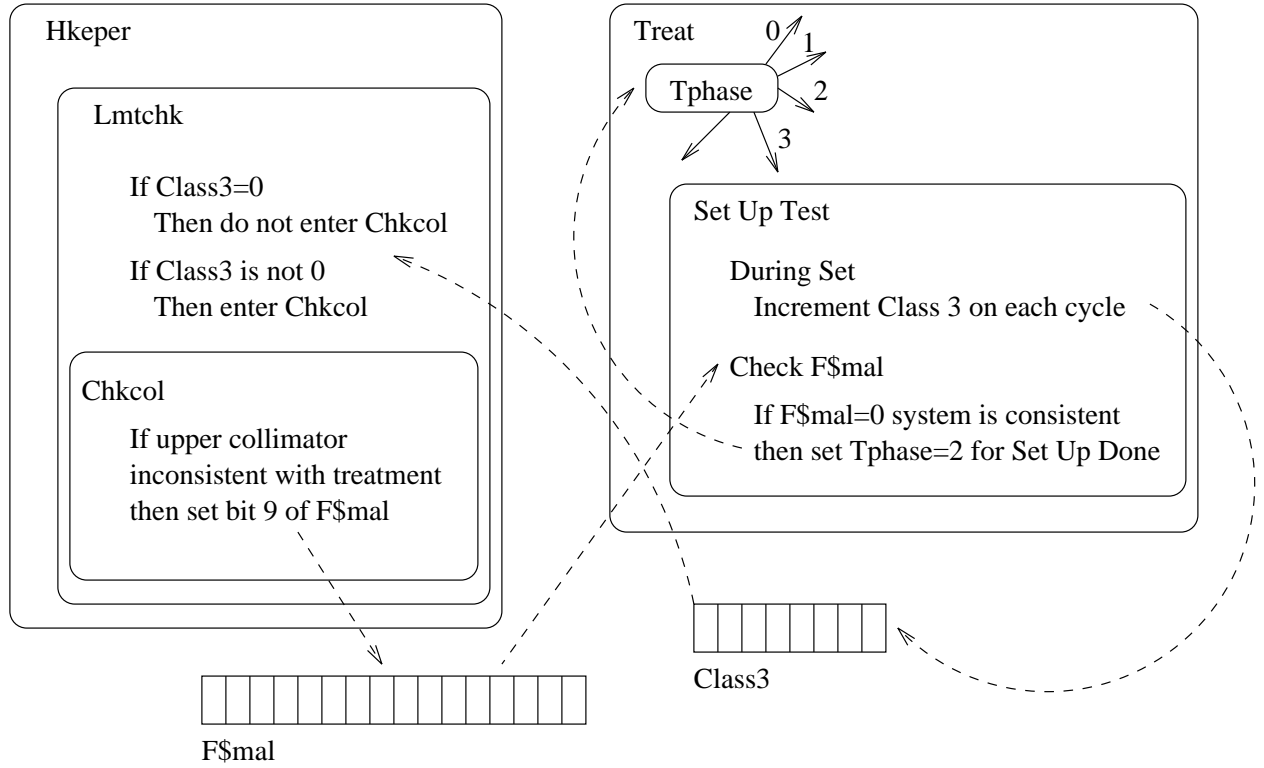
Figure 4: The Yakima software flaw.

The second Yakima accident was again attributed to a type of race condition in the software — this one allowed the device to be activated in an error setting (a “failure” of a software interlock). The Tyler accidents were related to problems in the data-entry routines that allowed the code to proceed to Set Up Test before the full prescription had been entered and acted upon. The Yakima accident involved problems encountered later in the logic after the treatment monitor Treat reaches Set Up Test.

The overexposure occurred when the operator hit the “set” button at the precise moment that Class3 rolled over to zero. Thus, Chkcol was not executed and F\$mal was not set to indicate that the upper collimator was still in the field-light position. The software turned on the full 25 MeV without the target in place and without scanning. A highly concentrated electron beam resulted, which was scattered and deflected by the stainless
